**Audit of Ambient Air Monitoring Stations
for the Sistema de Monitoreo Atmosférico de la Ciudad de México**

Eric Anderson
EPA Systems, LLC
Austin, Texas

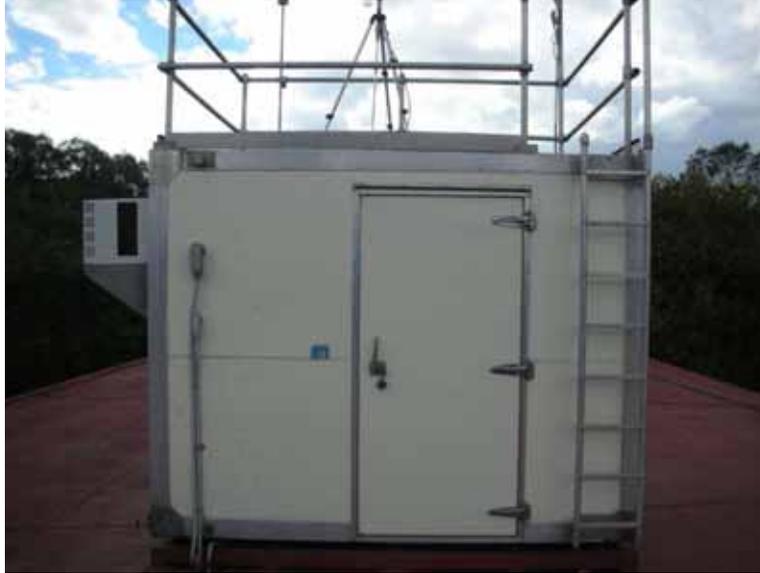
Figure 3.2. Photo of EAC Site

As this was the first site audited and the auditor had not previously used the Environics Model 6103 calibrator, certain nuisances of its operation may have resulted in the low recoveries for ozone and the GPT. Of the three GPT points, two indicated that the conversion was well within acceptable limits, but the third point was significantly outside the limit, which resulted in an average outside of the 96% conversion efficiency. This point may have been either miss-transcribed or the setting was improperly set. As the auditor believes that the issues with ozone at this site were likely caused by auditor error, no data are shown for the ozone and GPT are shown below.

It is recommended that during the next calibration, the ozone and GPT are checked to either confirm or refute these results. At this time specific corrective action is not recommended at this site. Sample results for each of the analyzers at this site are shown in Tables 3-1 to 3-3. A photo of this site is shown in Figure 3.2 below.

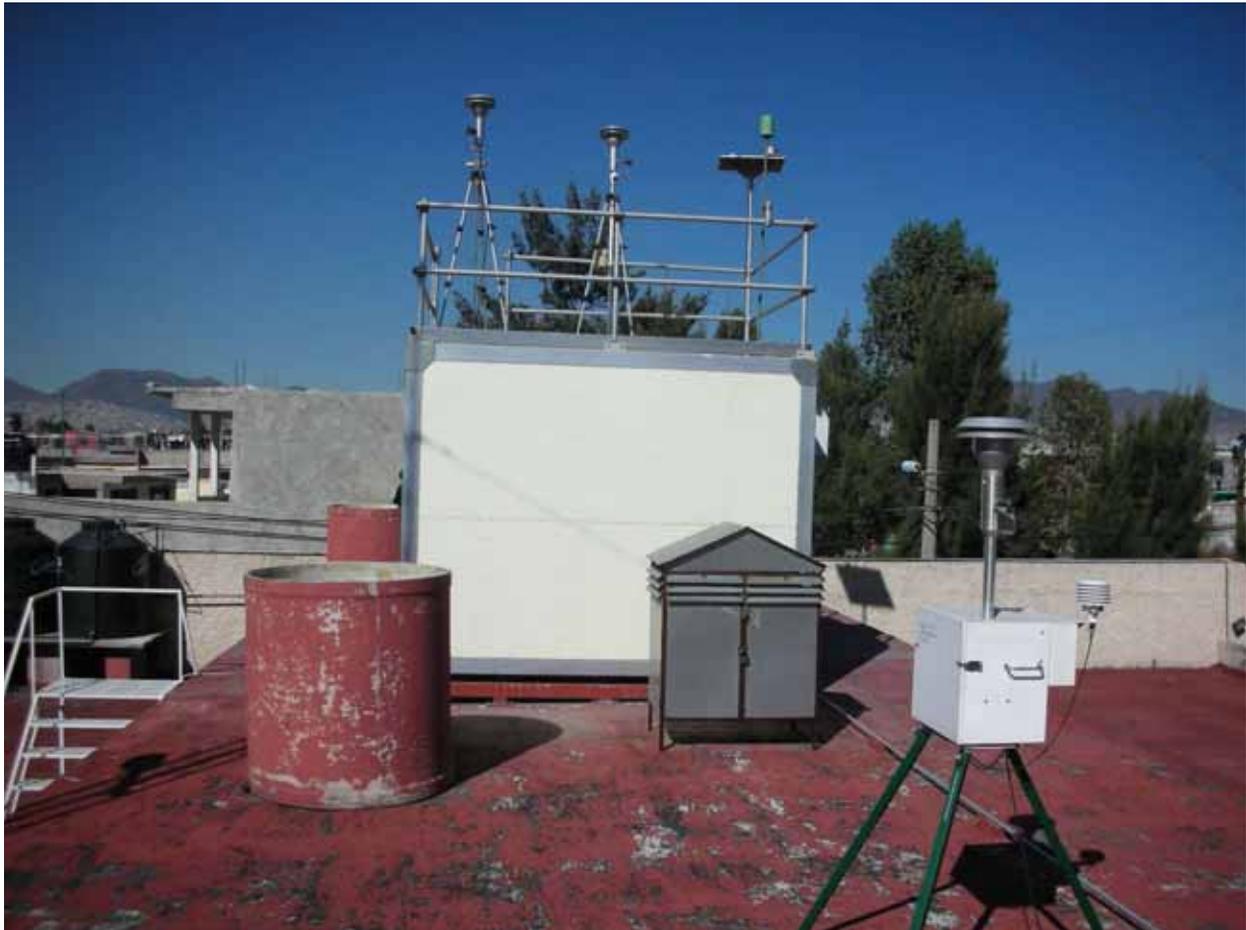
Figure 3-3. Photo of SAG Site

The station is located inside an Ekto Shelter located on the roof of a health care center. The equipment and site were well maintained and very clean. The audit results showed that all of the parameters were well within the average and individual audit objective of $\pm 15\%$. The average results for each of the analyzers were CO (1.2%), NO (7.1%), NO_x (7.7%), O₃ (-4.9%) and SO₂ (8.3%). The GPT showed that the NO₂ convertor efficiency was 99.6%.

The Shelter had a Thermo Andersen PM_{2.5} Beta Attenuation monitor and a TEOM Model 1400a PM₁₀. The flow rate through the PM₁₀ sampler was 17.02 lpm and through the PM_{2.5} was 16.59 lpm. Both values are well within specification for adequate impactor cut-points. A photo of this site is shown in Figure 3-3 below. There are no corrective actions associated with this site. Audit results for each of the analyzers at this site are shown in Tables 3-10 to 3-15.

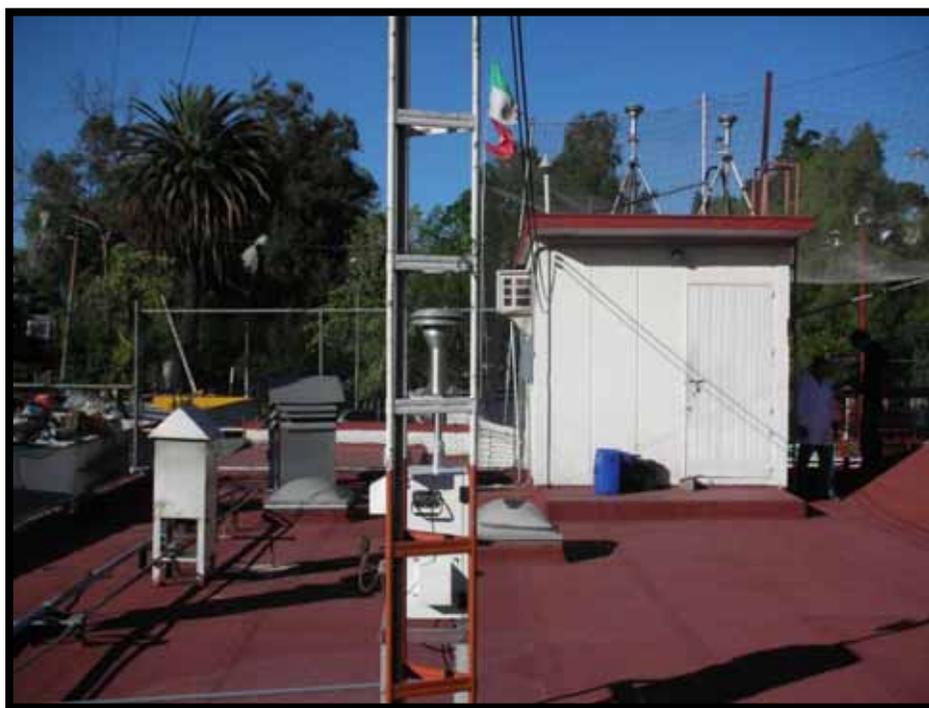
Figure 3-4. Photo of MER Site

The station is located inside a shed located on the roof of a health care center. The shelter was older but the equipment and site were well maintained and relatively clean. There were a number of manual PM samplers at this site including TSP, PM₁₀ and FRM PM_{2.5}. The audit results showed that all of the parameters were well within the average and individual audit objective of $\pm 15\%$ except SO₂. The average results for the analyzers were CO (-0.1%), NO (7.1%), NO_x (3.1%), O₃ (-0.5%) and SO₂ (-13.9%). While the average percent difference for SO₂ was within the audit objective, one of the four SO₂ points was slightly outside of the individual value objective of $\pm 15\%$ at -17.8%. In general, this was slow to respond and should be considered for maintenance. While the SO₂ parameter is generally slower to respond than other instruments, if the instrument has not reached 95% of the input value within 5 minutes, there is a risk that the instrument is not able to measure and record transitory elevations in ambient concentrations. The GPT showed good NO₂ convertor efficiency at 98.6%.

The Shelter had a TEOM 1400a-FDMS 8500 PM_{2.5} monitor and a TEOM Model 1400a PM₁₀. The flow rate through both samplers was well within specification for adequate impactor cut-points. A photo of this site is shown in Figure 3-4 below. Other than reviewing the SO₂ response and response time, there are no other corrective actions associated with this site. Audit results for each of the analyzers at this site are shown in Tables 3-16 to 3-21.

Site	Description of Concern or Observation	Recommendation
Primary Concerns		
MER	One SO ₂ audit response was outside the audit objective of ±15% and analyzer was slow to respond	Perform maintenance on analyzer and determine reason for slow (and low) response
IZT	Three SO ₂ audit responses were outside the audit objective of ±15% and analyzer was slow to respond	Perform maintenance on analyzers and determine reason for slow (and low) response
SUR	Two SO ₂ audit responses were outside the audit objective of ±15% and analyzer was slow to respond	Perform maintenance on analyzers and determine reason for slow (and low) response
Secondary Concerns		
EAC	Ozone and GPT may be out of specification	Verify that readings were auditor error and that the ozone analyzer is working properly
All Sites	GPT checks are performed using only 2 points.	Three points should be used to assess convertor performance
All Sites	Frequently site departure times were not recorded in the station logbook	Record both arrival and departure time in the station logbook

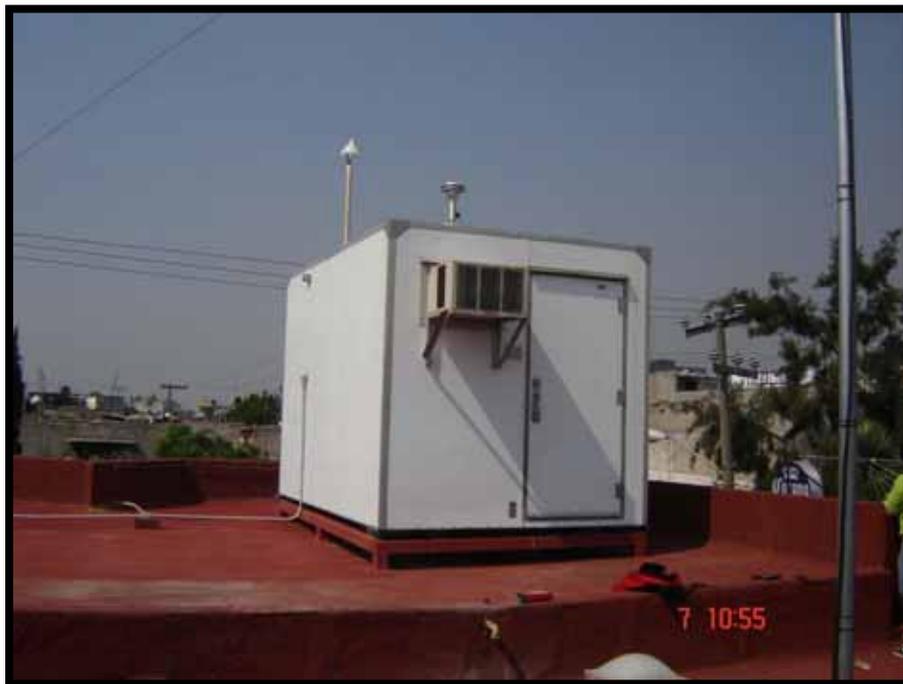
Figure 3-6. Photo of the IZT Site

This station is in a low-income residential area housed in a Shelter One shelter located on the top of the second floor of a health center. The shelter and equipment were well maintained and very clean. The audit results showed that all of the parameters were well within the average and individual audit objective of $\pm 15\%$ except SO_2 . The average results for the analyzers were CO (-1.0%), NO (5.3%), NO_x (6.9%), O_3 (1.8%) and SO_2 (-18.9%). The average percent difference as well as three out of four individual audit points for SO_2 was outside the audit objective. This instrument was extremely slow to respond and needs to be carefully checked. The auditor allowed over 20 minutes for one calibration point to stabilize, and the instrument was still rising at about 1 ppb per minute. While SO_2 instruments are generally slower to respond than other instruments, if the instrument cannot reach 95% of the input value within 5 minutes, there is a risk that the instrument is not able to measure and record transitory elevations in ambient concentrations. So while this instrument may have eventually calibrated if given unlimited time, there is a response time issue that needs to be considered with any instrument, and this analyzer clearly has response time issues. The GPT showed good NO_2 convertor efficiency at 101%.

The Shelter had a Thermo Andersen PM_{10} Beta Attenuation monitor. The flow rate through the sampler was well within specification for adequate impactor cut-points at 17.04 lpm. A photo of this site is shown in Figure 3-6 below. Other than reviewing the SO_2 response, and response time, there are no other corrective actions associated with this site. Audit results for each of the analyzers at this site are shown in Tables 3-28 to 3-33.

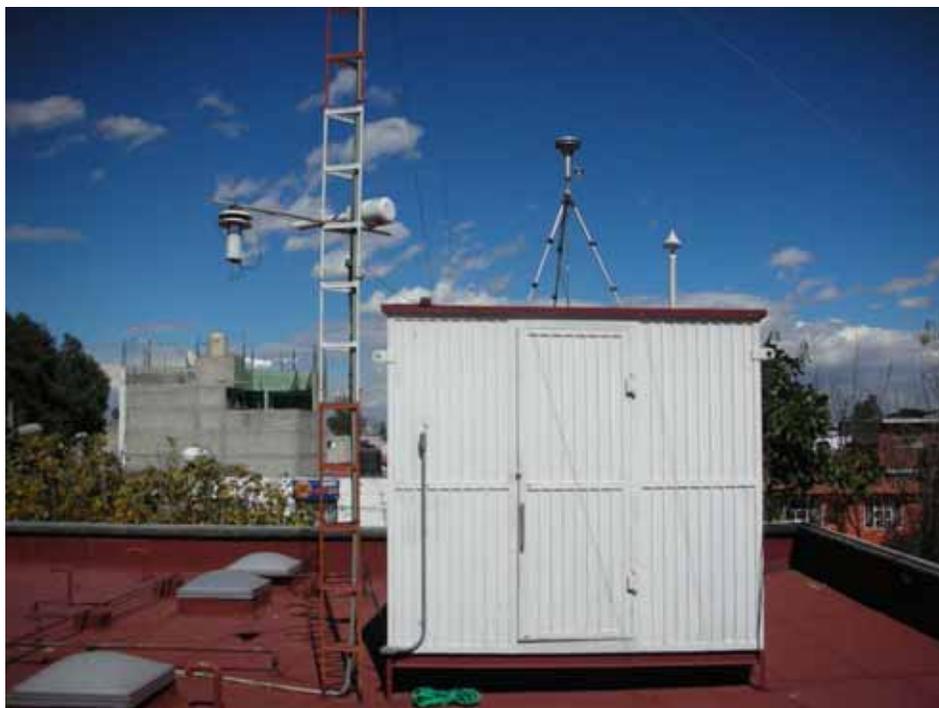
Figure 3-7. Photo of the SUR Site

For SO_2 , the average percent difference was within the $\pm 15\%$ audit objective, but two of the four individual audit points were slightly outside of the audit objective (15.4%). This instrument (an older API Model 100) appeared to have a very slow response plus a problem with the display value versus the PMT value. With the instrument sampling the audit gas, the PMT value would escalate, but the ppm value would remain the same or barely rise. When you pressed the {CALM} button on the front panel (the method used by the operators to calibrate the instrument) the ppm reading would jump suddenly to be more in line with the PMT value. For example, when checking the 330 ppb audit point, the PMT reading went from 1900 mv to 2450 mv but the concentration display only increased 3 ppb (194 to 197). When the {CALM} button was pressed the display reading went to 259 ppb. This very slow response of the concentration display may produce bias in transient SO_2 concentrations. Since this was occurring during the audit which simulates ambient values, this suggests that changes in ambient concentration could be significantly biased in the same manner the audit values were (e.g., the PMT values increase but the ppb readout does not). The response time issue needs to be addressed and this instrument should be evaluated to determine what is causing this unusual response.

The shelter was equipped with a TEOM PM_{10} analyzer. The flow rate through the sampler was well within specification for adequate impactor cut-points at 16.65 lpm. This is slightly lower than other TEOM flow rates which were typically 17 lpm. It was noted that the Auxiliary filter was very dark which may have been causing the very slight flow reduction. A photo of this site is shown in Figure 3-7 below. Other than reviewing the SO_2 response and response time, there are no other corrective actions associated with this site. Audit results for each of the analyzers at this site are shown in Tables 3-34 to 3-39.

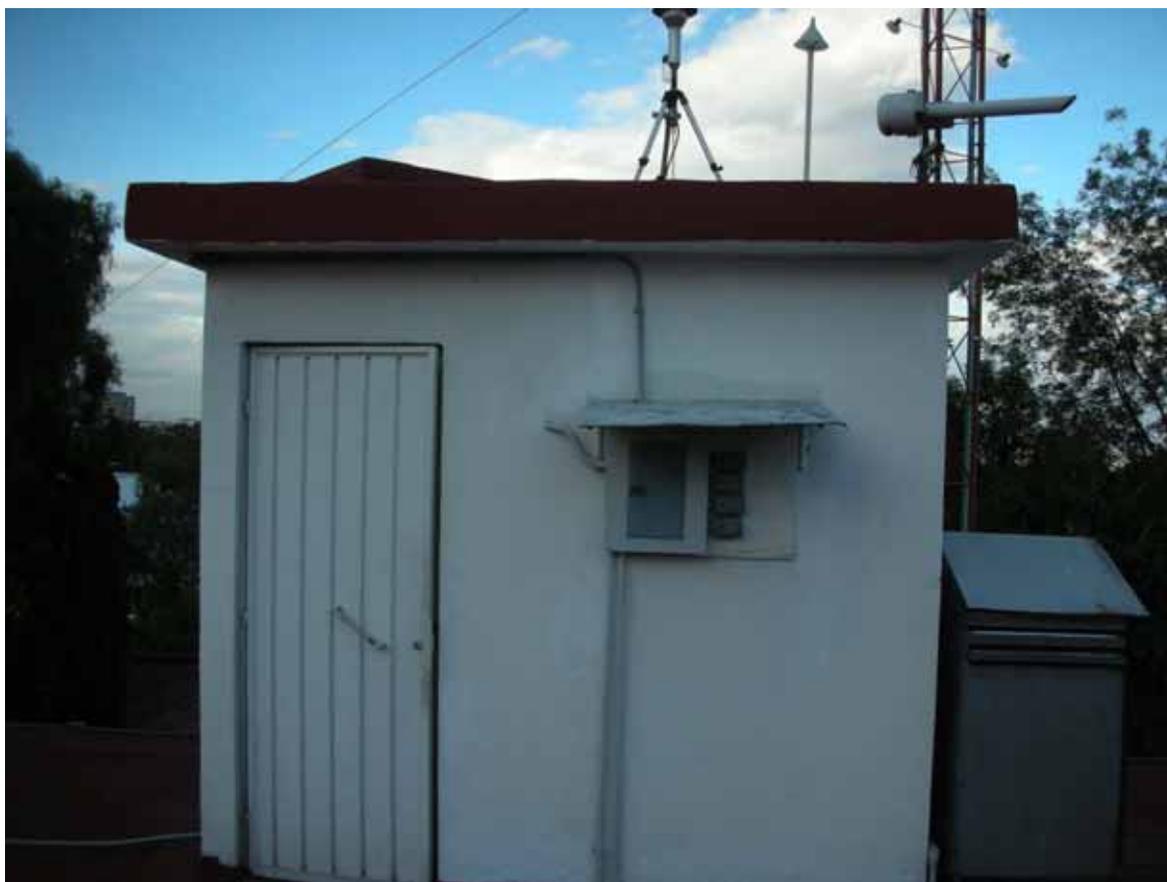
Figure 3-8. Photo of PED Site

This station is in a high-income residential area in southwest Mexico City housed in a shed on the top of the second floor of an elementary school. The shelter was very old and cramped but the equipment was well maintained. An API calibrator and air source have been installed at this site for future calibrations, but the installation was not complete or operable at the time of the audit. The audit results showed that all of the parameters were well within the average and individual audit objective of $\pm 15\%$. The average results for the analyzers were CO (-1.5%), NO (3.3%), NO_x (4.5%), O₃ (-0.4%) and SO₂ (-5.4%). The GPT showed good NO₂ convertor efficiency at 101%.

The shelter was equipped with a TEOM PM₁₀ analyzer. The flow rate through the sampler was well within specification for adequate impactor cut-points at 16.97 lpm. A photo of this site is shown in Figure 3-8 below. There are no corrective actions associated with this site. Audit results for each of the analyzers at this site are shown in Tables 3-40 to 3-45.

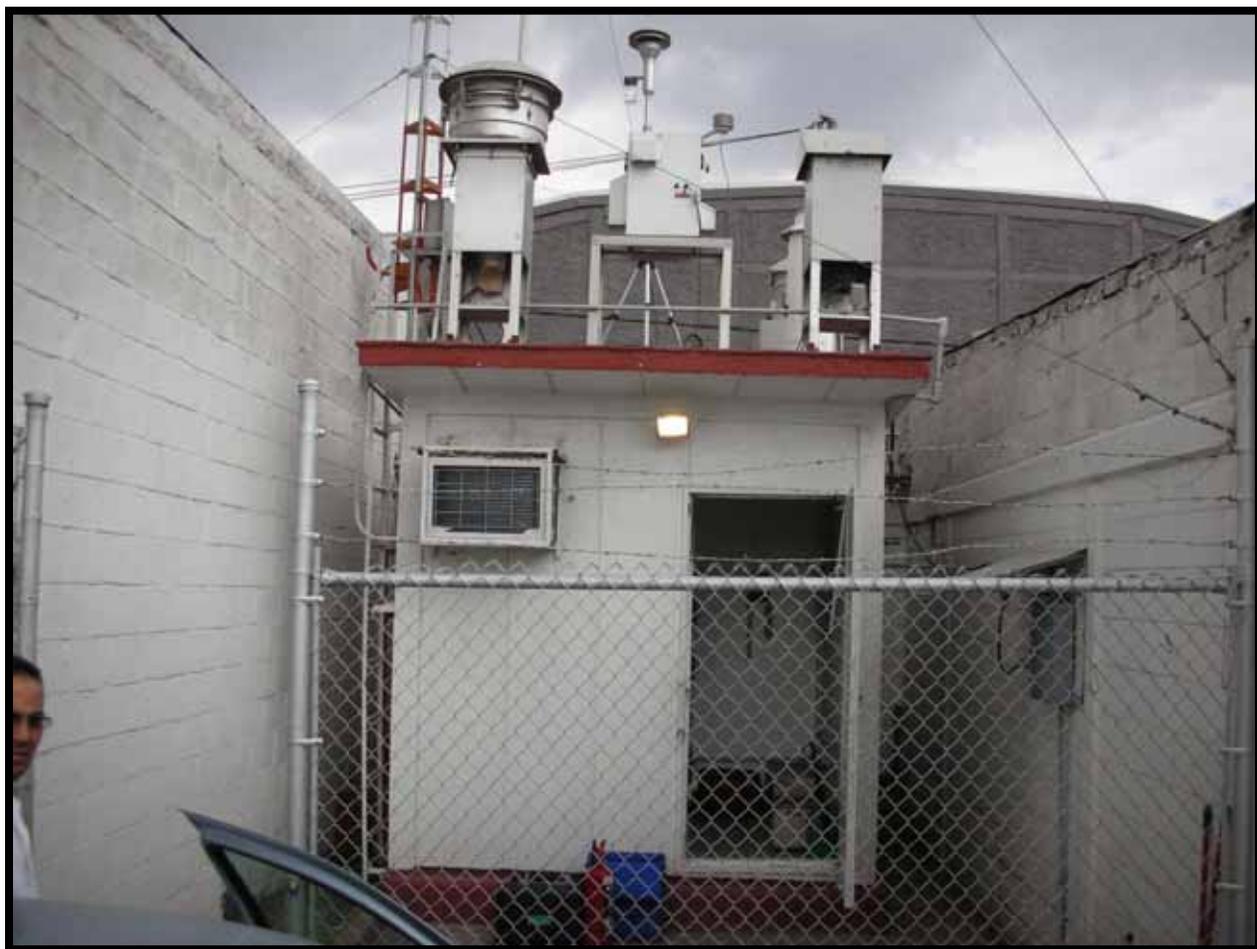
Figure 3-9. Photo of the XAL Site

This station is in an industrial/commercial/residential area. The site is in a shed on the back lot of a car dealership. The station is less than 10 meter away from a major avenue

with heavy traffic. The inlet location is somewhat blocked by an automobile detail building on one side of the shed. Sample inlet is 4.5 m above ground level.

This station is in an industrial/commercial/residential area. The site is in a shed on the back lot of a car dealership. The exposure around the site is partially blocked by surrounding buildings. The shelter was very old and cramped but the equipment was well maintained. The audit results showed that all of the parameters were well within the average and individual audit objective of $\pm 15\%$. The average results for the analyzers were CO (-0.8%), NO (-0.9%), NO_x (-2.7%), O₃ (-0.4%) and SO₂ (-5.0%). The GPT showed good NO₂ convertor efficiency at 99.4%.

The shelter was equipped with a TEOM PM₁₀ analyzer. The flow rate through the sampler was well within specification for adequate impactor cut-points at 16.98 lpm. A photo of this site is shown in Figure 3-9 below. There are no corrective actions associated with this site. Audit results for each of the analyzers at this site are shown in Tables 3-46 to 3-51.
