Sistema de Monitoreo Atmosférico de la Ciudad de México

Ambient Air Quality Monitoring Audit Report

October 2018

Air Quality Monitoring Site Audit Report

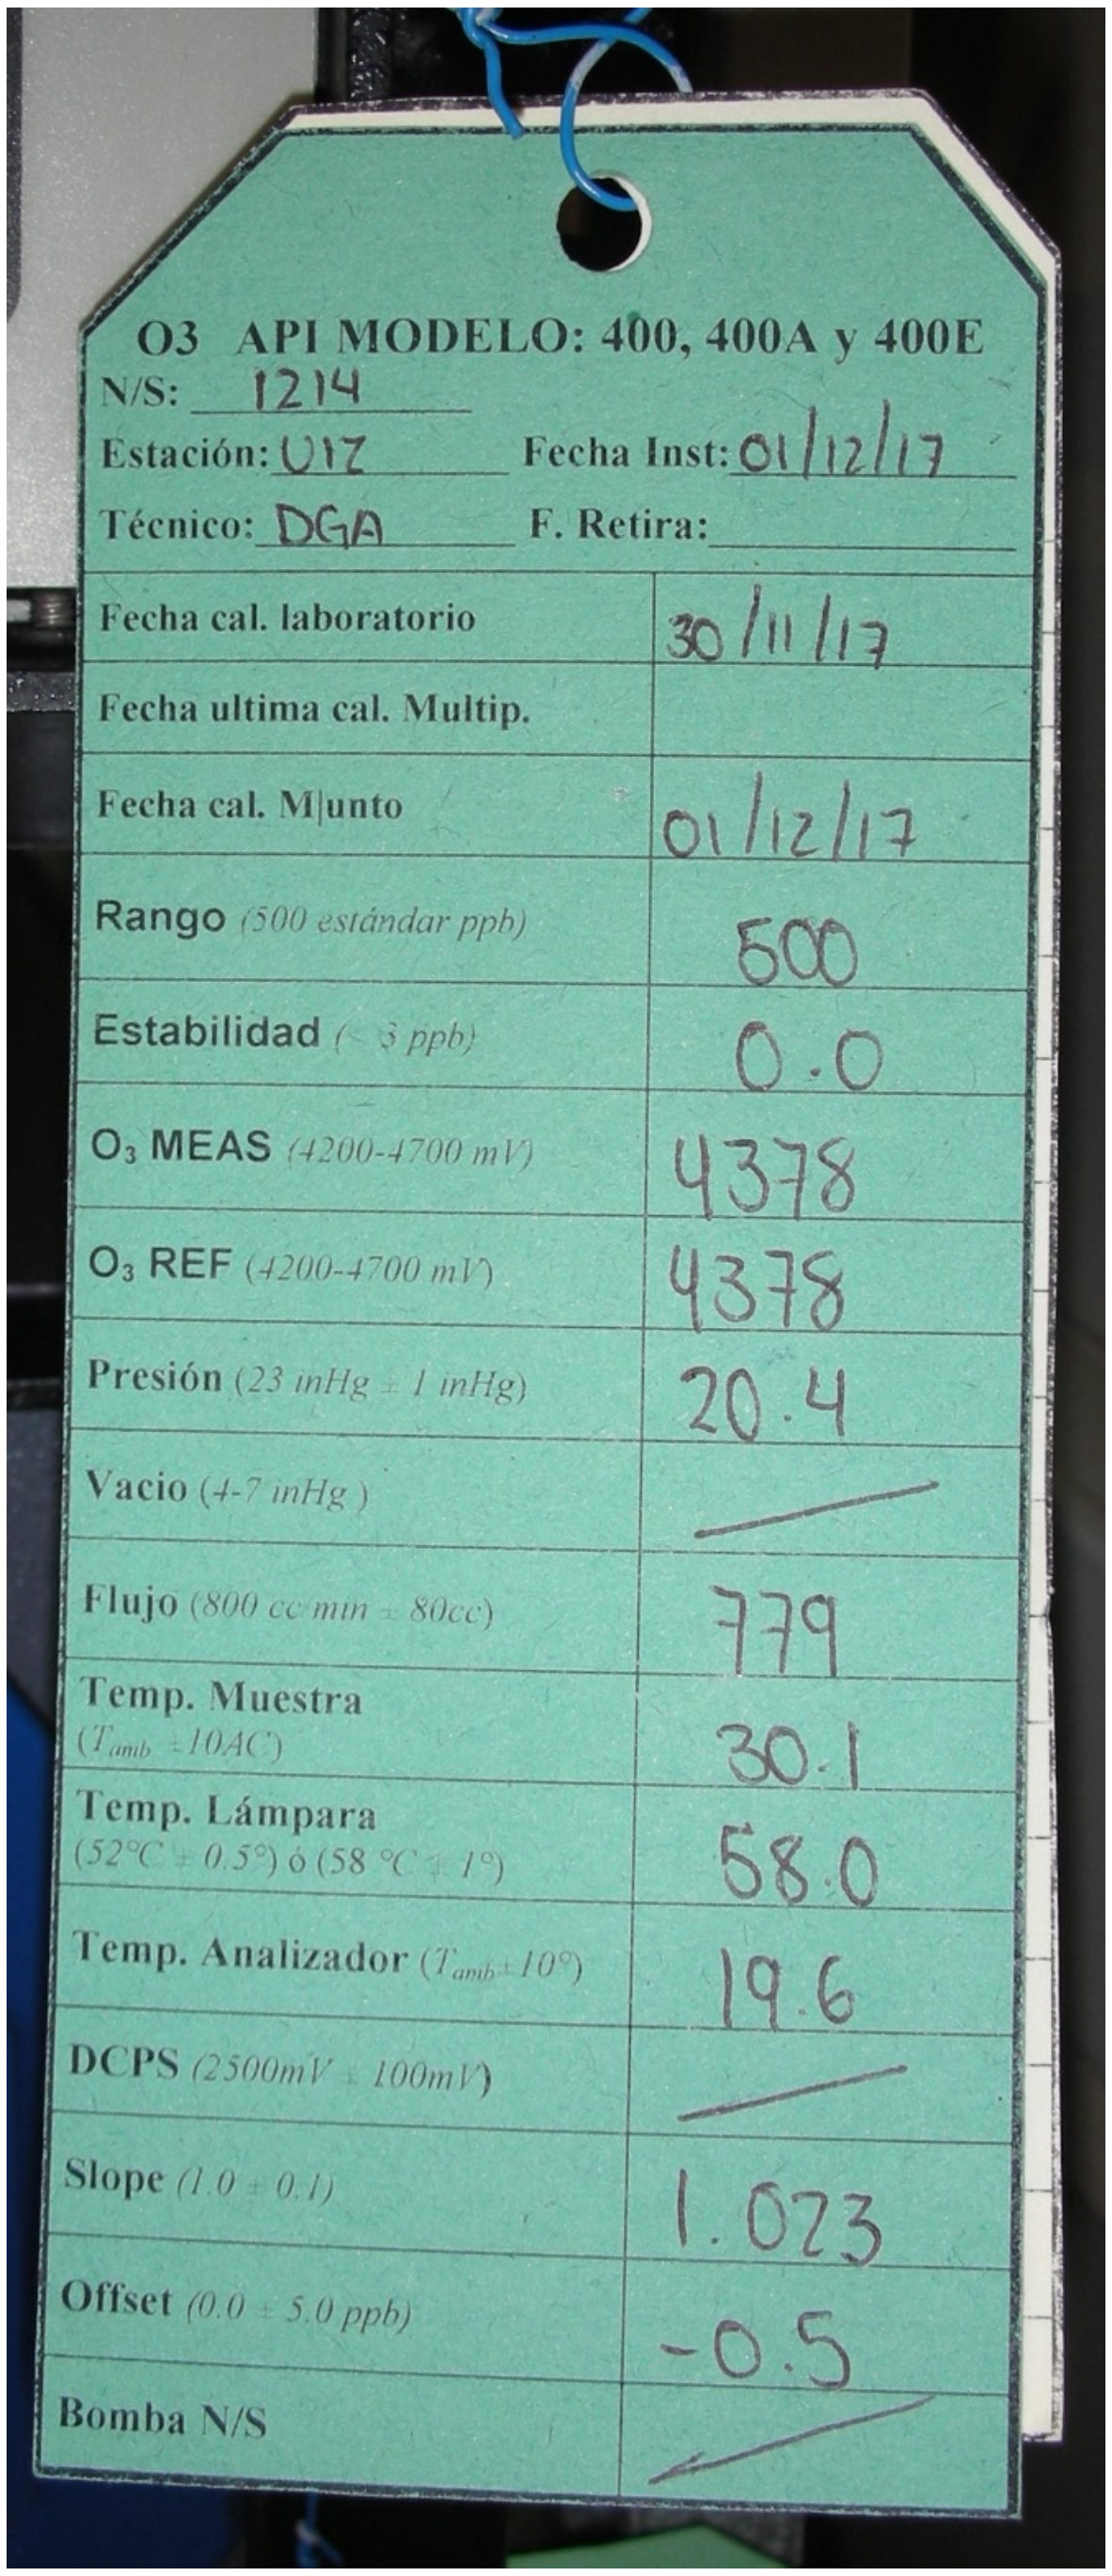
Figure 3-1. Photo of Instrument Information Tag

There were many "best practices" that the network uses to help ensure quality. There are Standard Operating Procedures (SOPs) for most of the analyzers, however with manpower limitations SOPs have not kept up with changing procedures and new analyzers. During each quarterly multipoint calibration, instrument diagnostics information and instrument performance parameters are recorded for each instrument and written on a heavy paper tag that is affixed to each analyzer and in the site log. A photograph of one of these tags is shown in Figure 3-1. Each time an operator goes to a site to perform calibrations or other maintenance activities, the current operational parameters are reviewed based on the values listed on each instrument's performance tag. Any significant changes from the values on the tag may be indicative of a possible instrument malfunction or degraded performance. As this information is typically available (depending on how long an individual instrument has been at a site) for a given instrument for at least one year if not longer, these tags allow an operator to very quickly determine if the current instrument performance has degraded (such as PMT voltage) since last multipoint calibration.

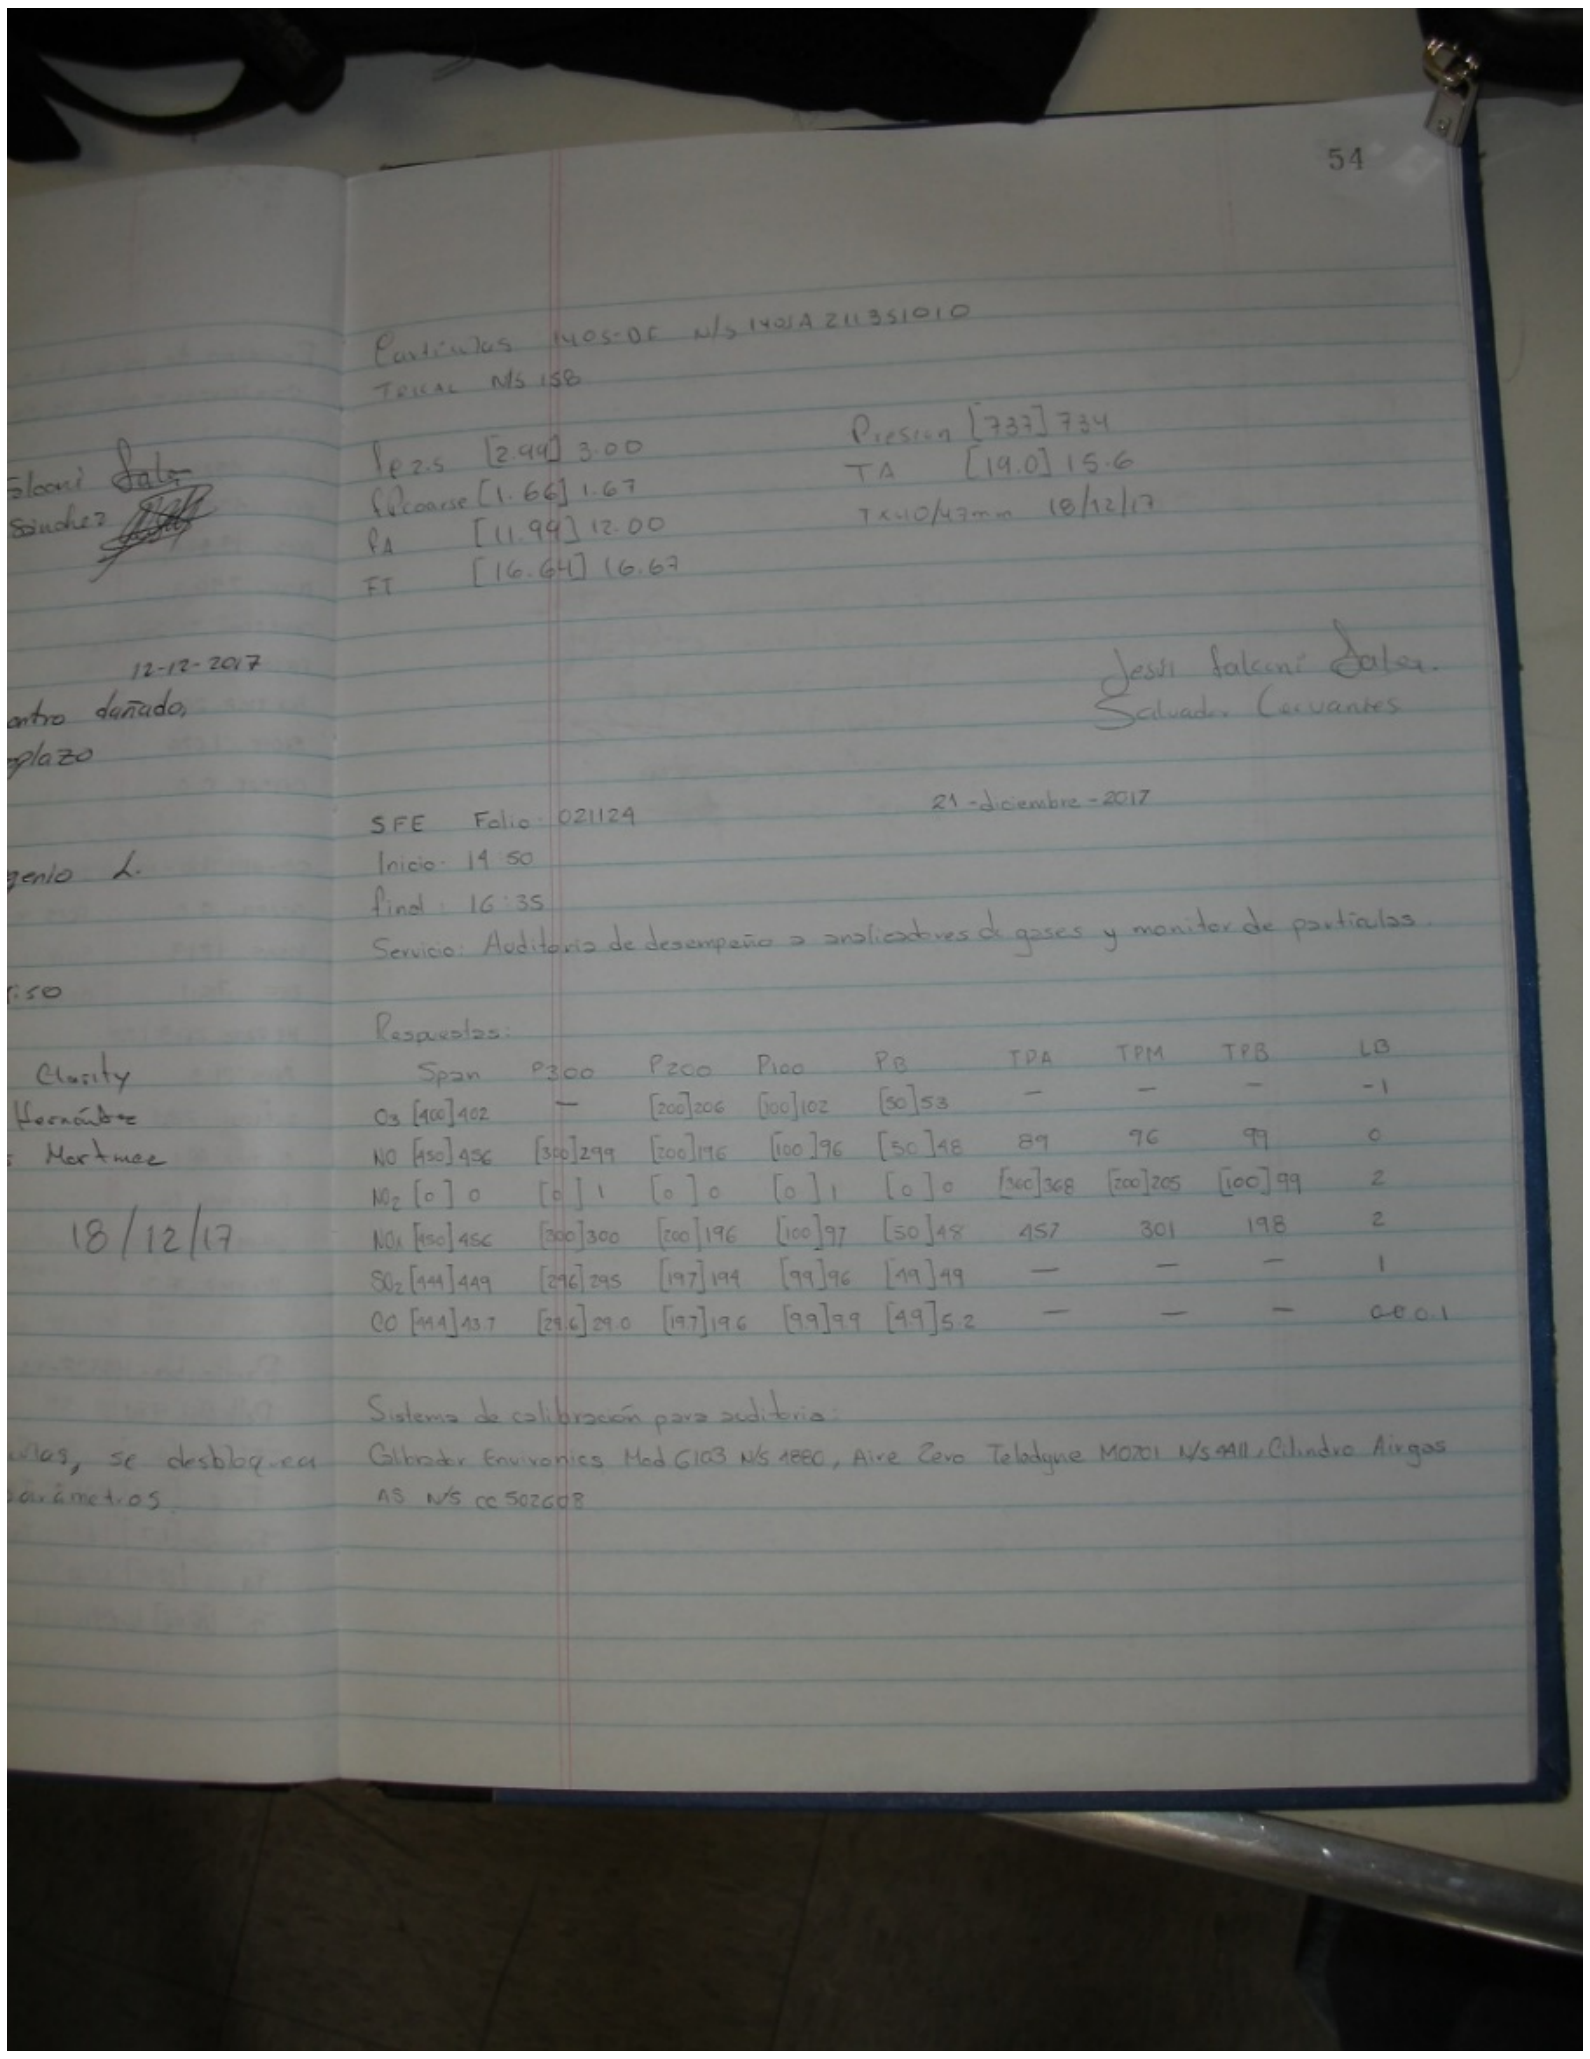
Figure 3-2. Photo of Site Log Book Entries

A review of the site operator logs showed operators were very good at documenting their on-site activities. Entries were written in ink, cross-outs were properly done, entries were signed and dated, and the time in and out documented. Figure 3-2 shows a photo of a typical logbook entry.
